Lessons learned from our accident at Fukushima Nuclear Power Stations

December 12, 2011

GLOBAL 2011 @Makuhari, Japan

Tokyo Electric Power Company

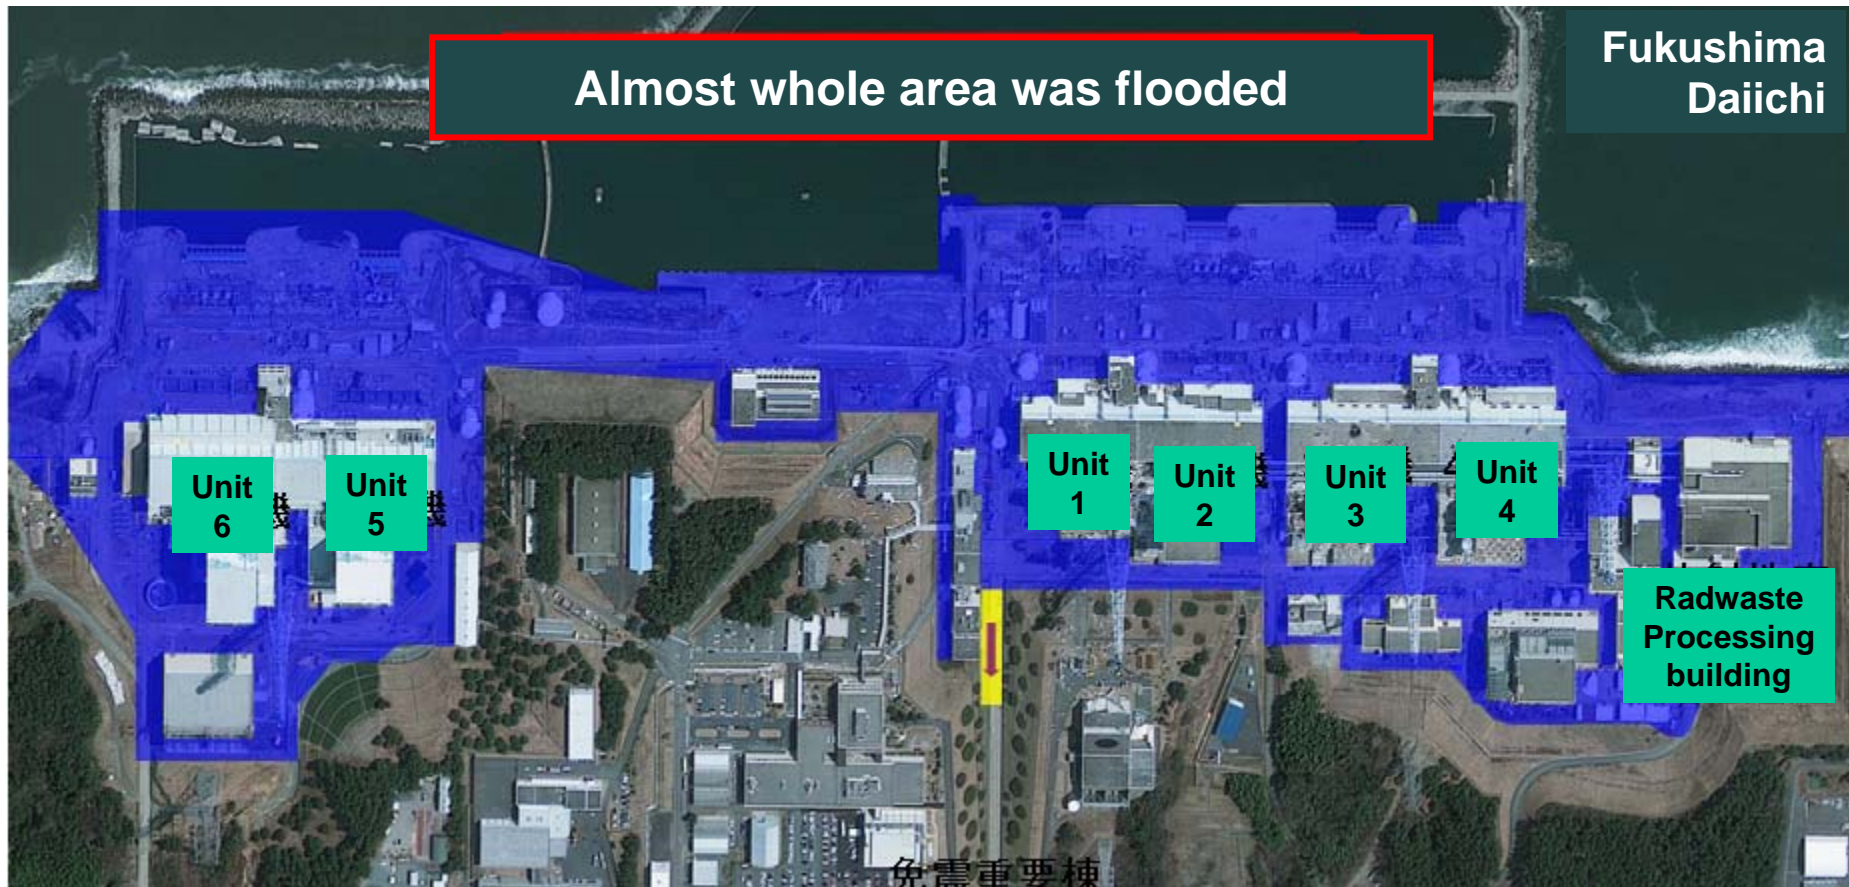
Inundated Areas at Fukushima Daiichi Nuclear Power Station

- Inundation throughout almost all areas where main buildings sited
 - ✓ Units 1~4: Inundation height in areas where principal buildings sited: OP approx. 11.5m~15.5m
(Localized inundation height in southwest area: OP approx. 16m~17m)
 - ✓ Unit 5 & 6: Inundation height in areas where principal buildings sited: OP approx. 13m~14.5m

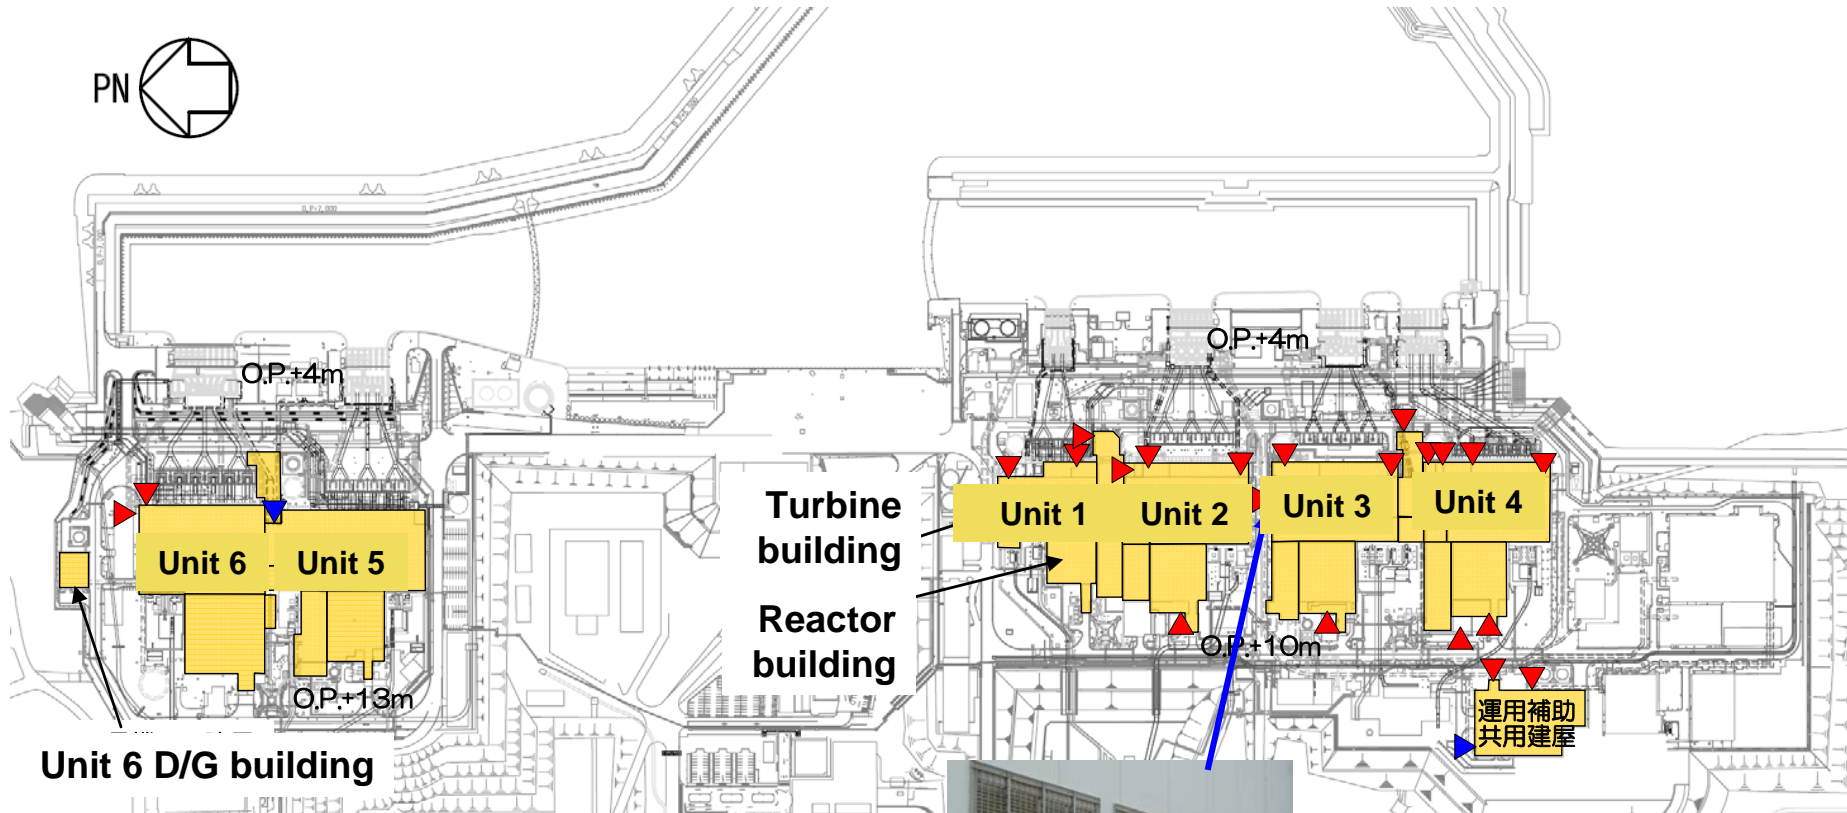
Location of Openings from which Sea Water could Flow into Main Buildings (Fukushima Daiichi Nuclear Power Station)

▼ : Openings at the ground level from which sea water could flow into buildings
 ▼ : Openings connected to underground trenches/ducts where sea water could flow into buildings

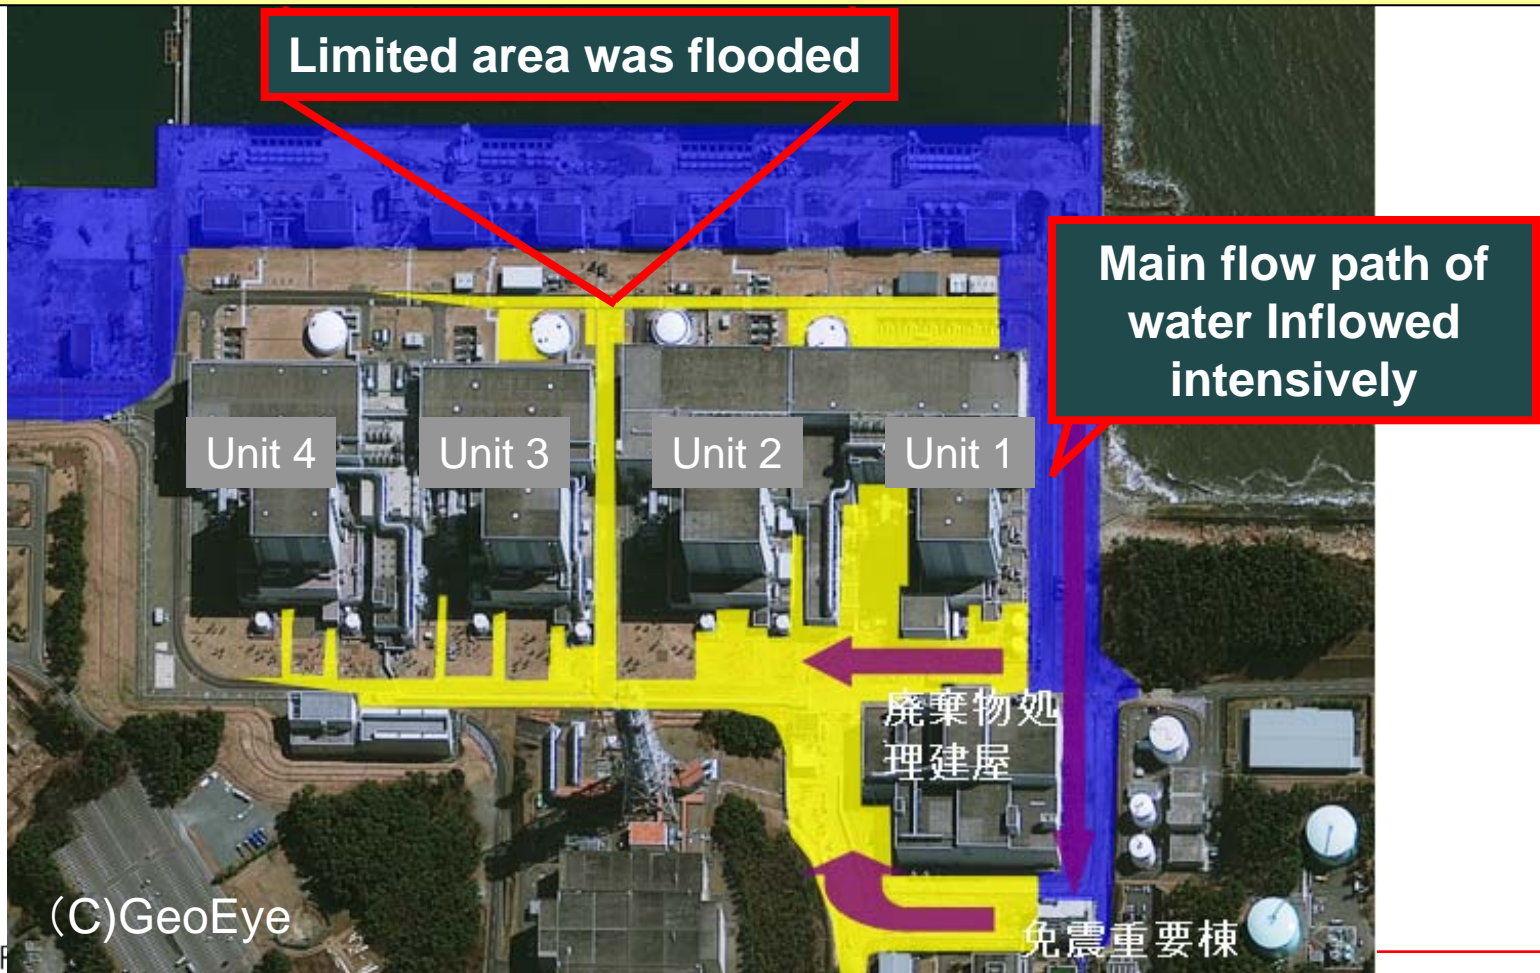
Inundated Areas at Fukushima Daini Nuclear Power

- Inundation occurred throughout all areas along the sea, but it was not observed to have inundated over the slope and into areas where major buildings are sited.
- Run up of tsunami centered on the south side of Unit 1
 - ✓ Inundation height in sea side area: OP approx. +7.0~7.5m
 - ✓ Inundation height in areas where principal buildings sited: OP approx. 12~14.5m
 - ✓ Inundation height in area south of Unit 1: OP approx. + 15~16m

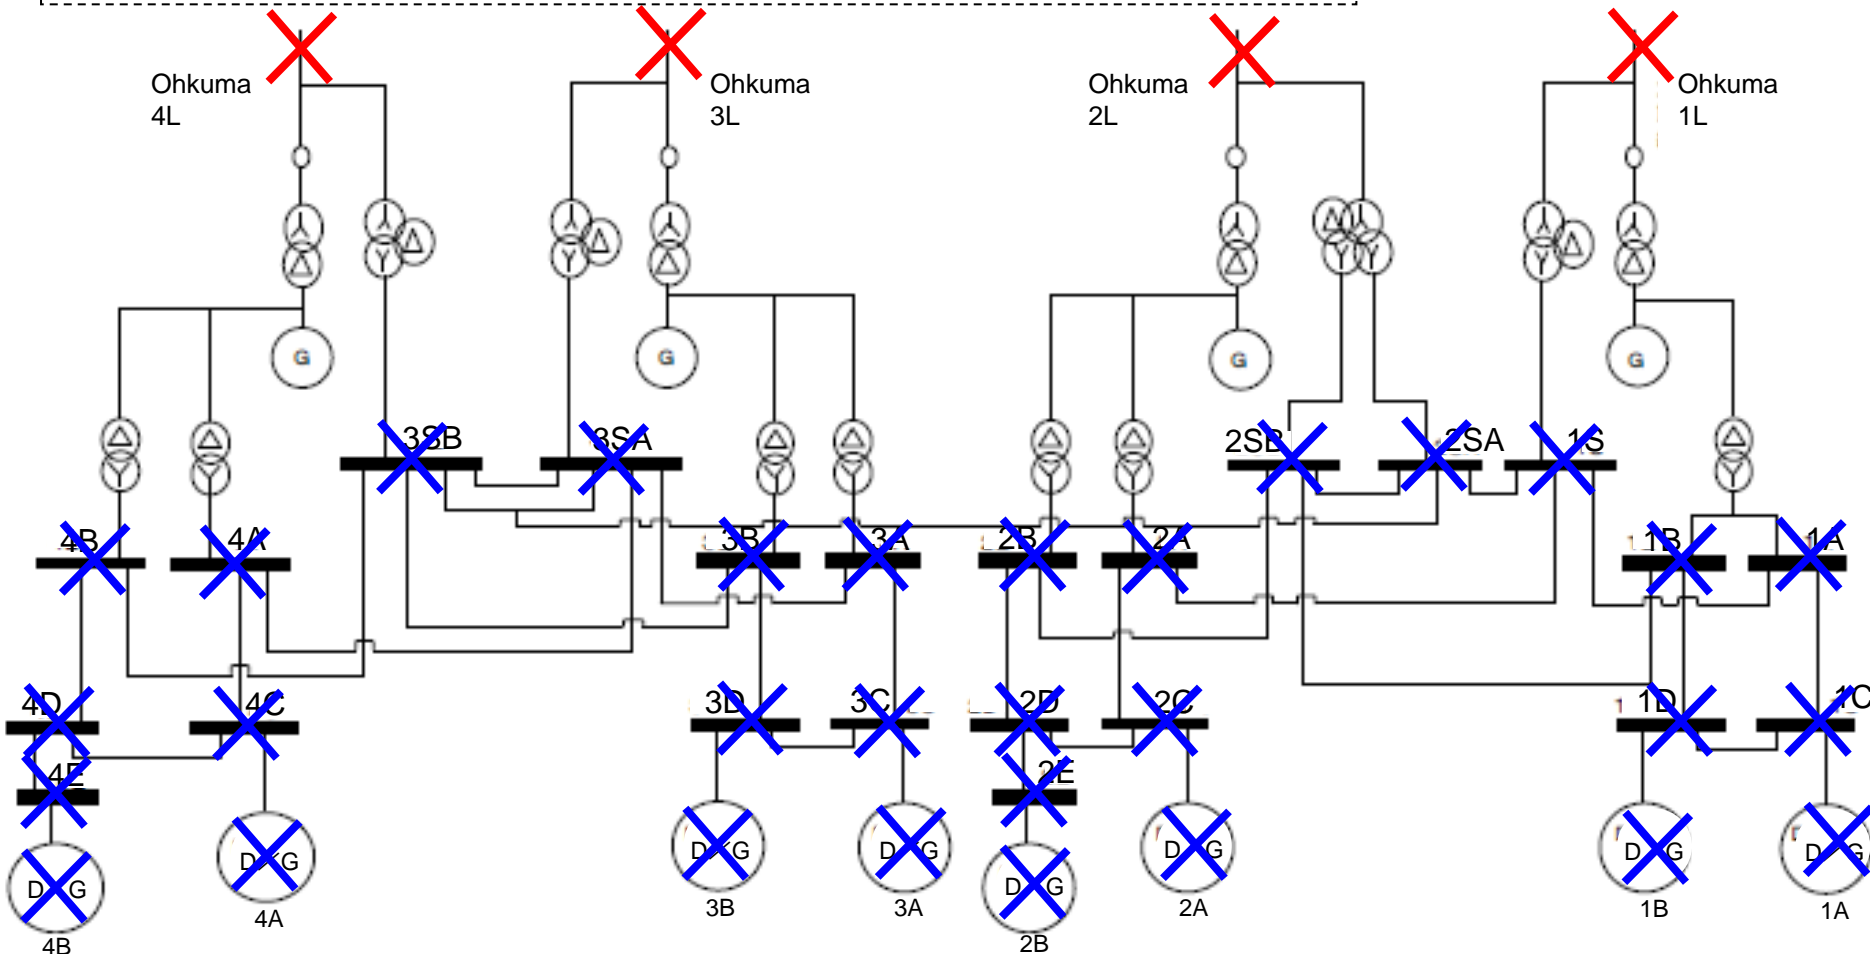
Power supply of Unit 1-4 @ 1F after Tsunami

Okuma Line 1L, 2L: Receiving circuit breaker damaged in earthquake
 Okuma Line 3L: Renovation work in progress
 Okuma Line 4L: Circuit breaker shutdown by protection relay activation

The DG lost the function due to either "M/C failure," "loss of sea water system," or "DG main unit failure."

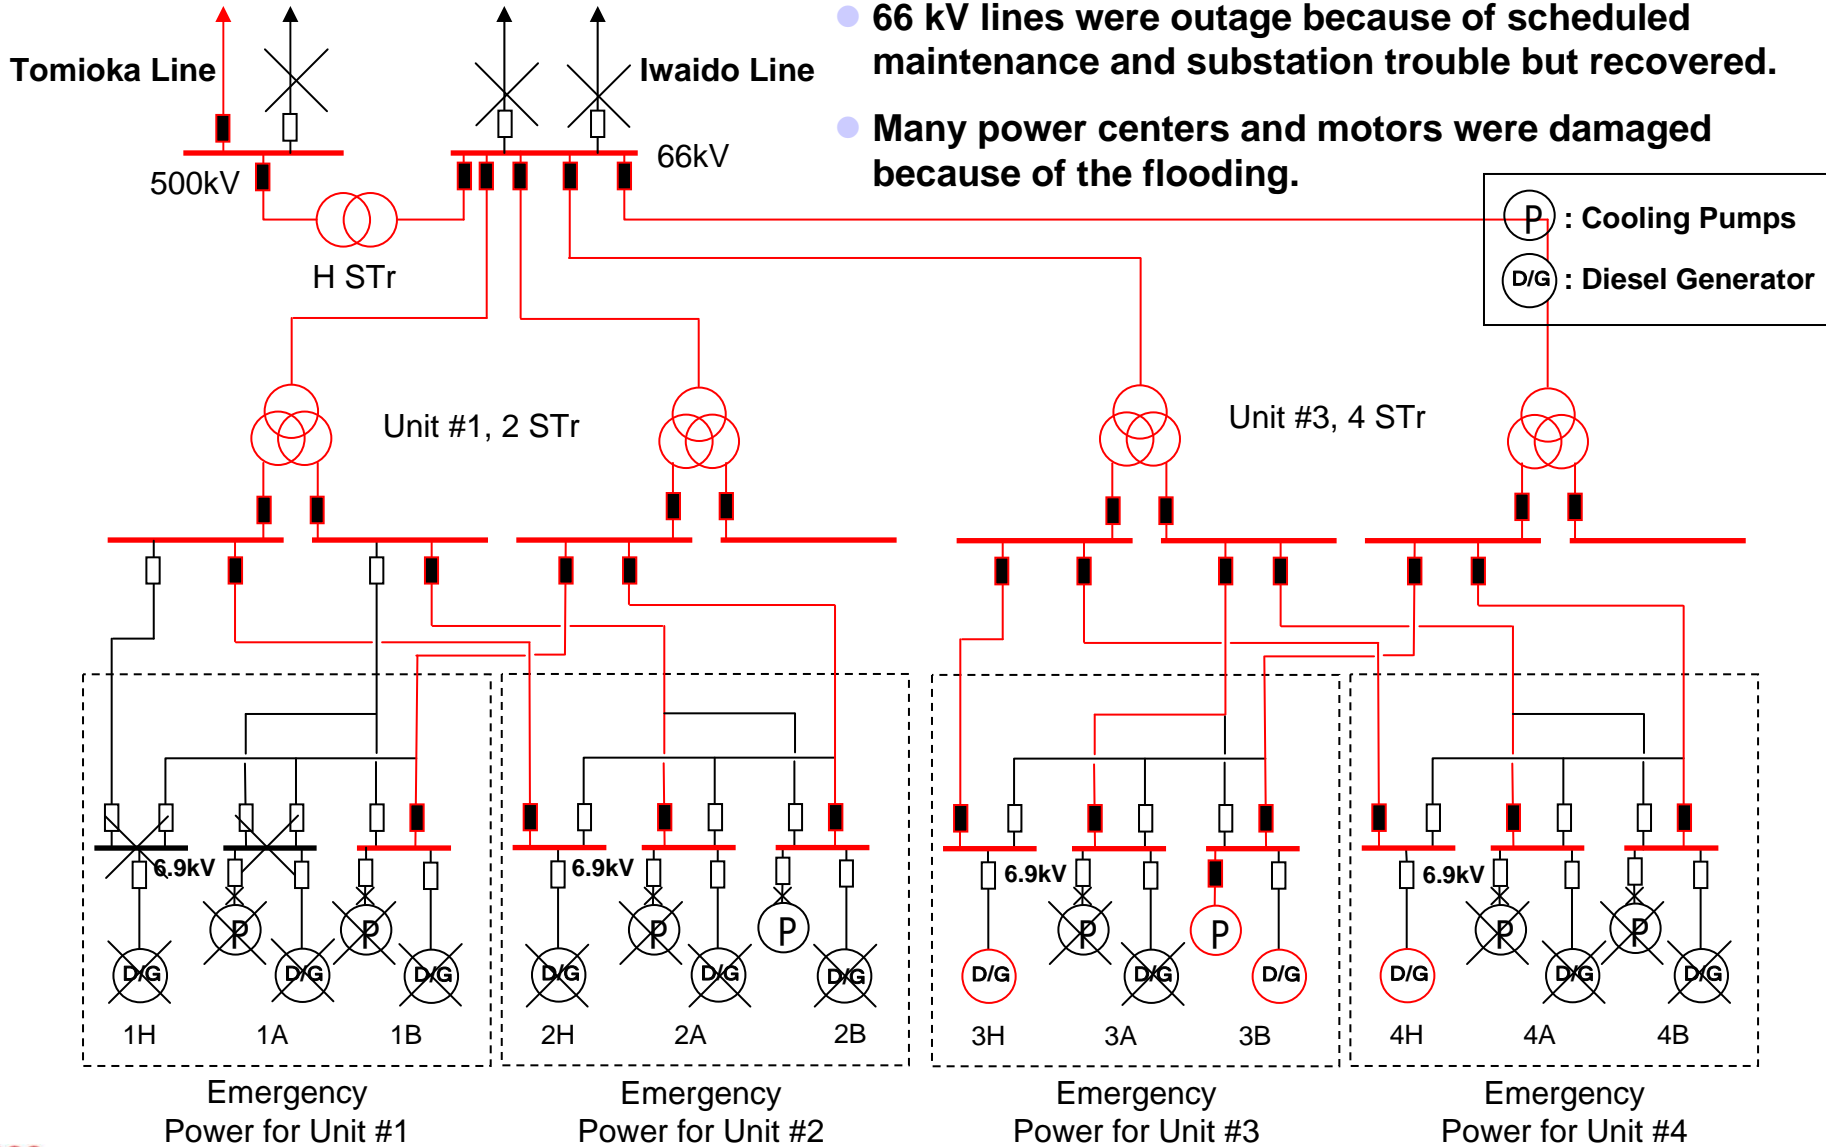
2F Offsite Power was secured after the Tsunami

- One 500 kV line was available.
- 66 kV lines were outage because of scheduled maintenance and substation trouble but recovered.
- Many power centers and motors were damaged because of the flooding.

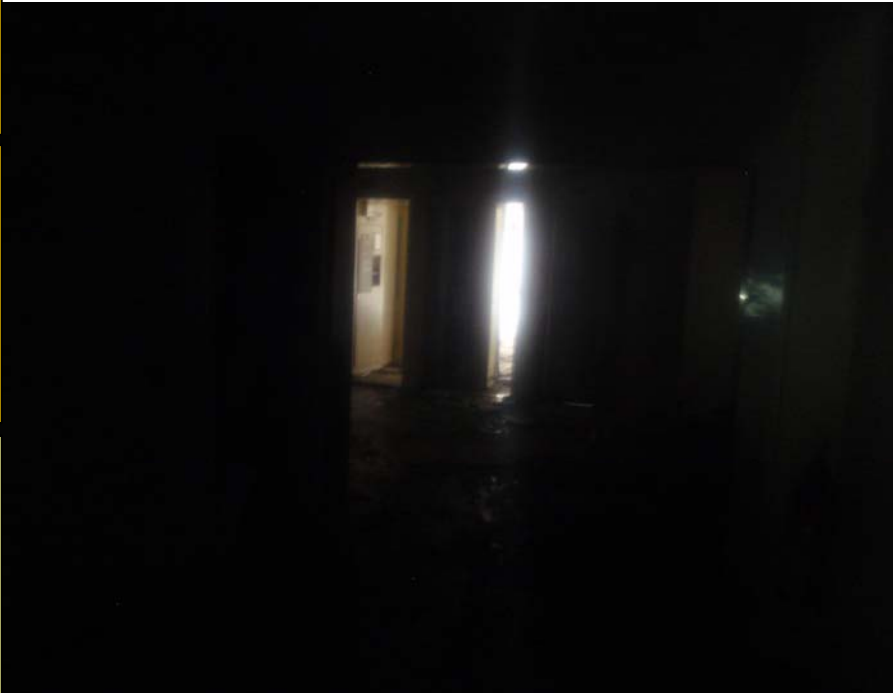
Work in complete darkness
In the service building. Many scattered objects were also on the floor.

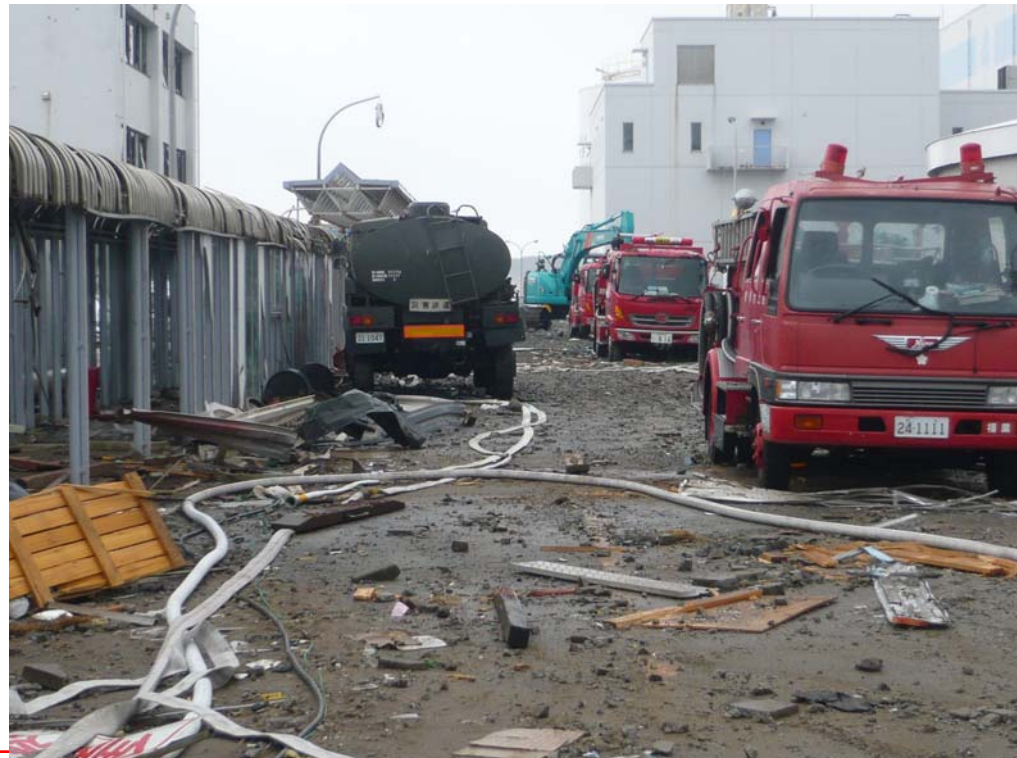
Obstacles on access routes

Debris caused difficulties moving equipment such as fire hoses but after the explosions additional rubble and damaged fire engines made it more difficult.

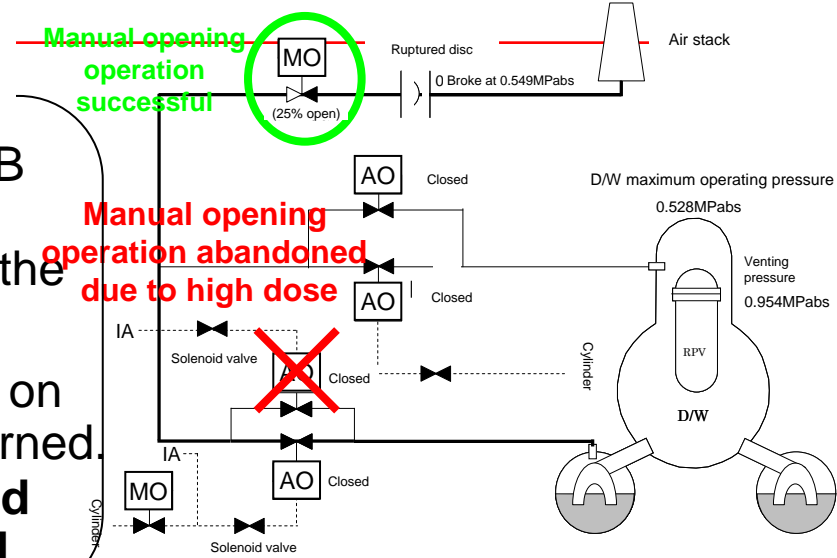
- 2nd team entered the torus room (R/B B1F), but the valve was located at a direction of 180 degrees from where the team entered the torus room.
- The survey meter rose up to the limit on the way, and the team members returned.
- ➡ **Manual operation was abandoned and another means was selected**

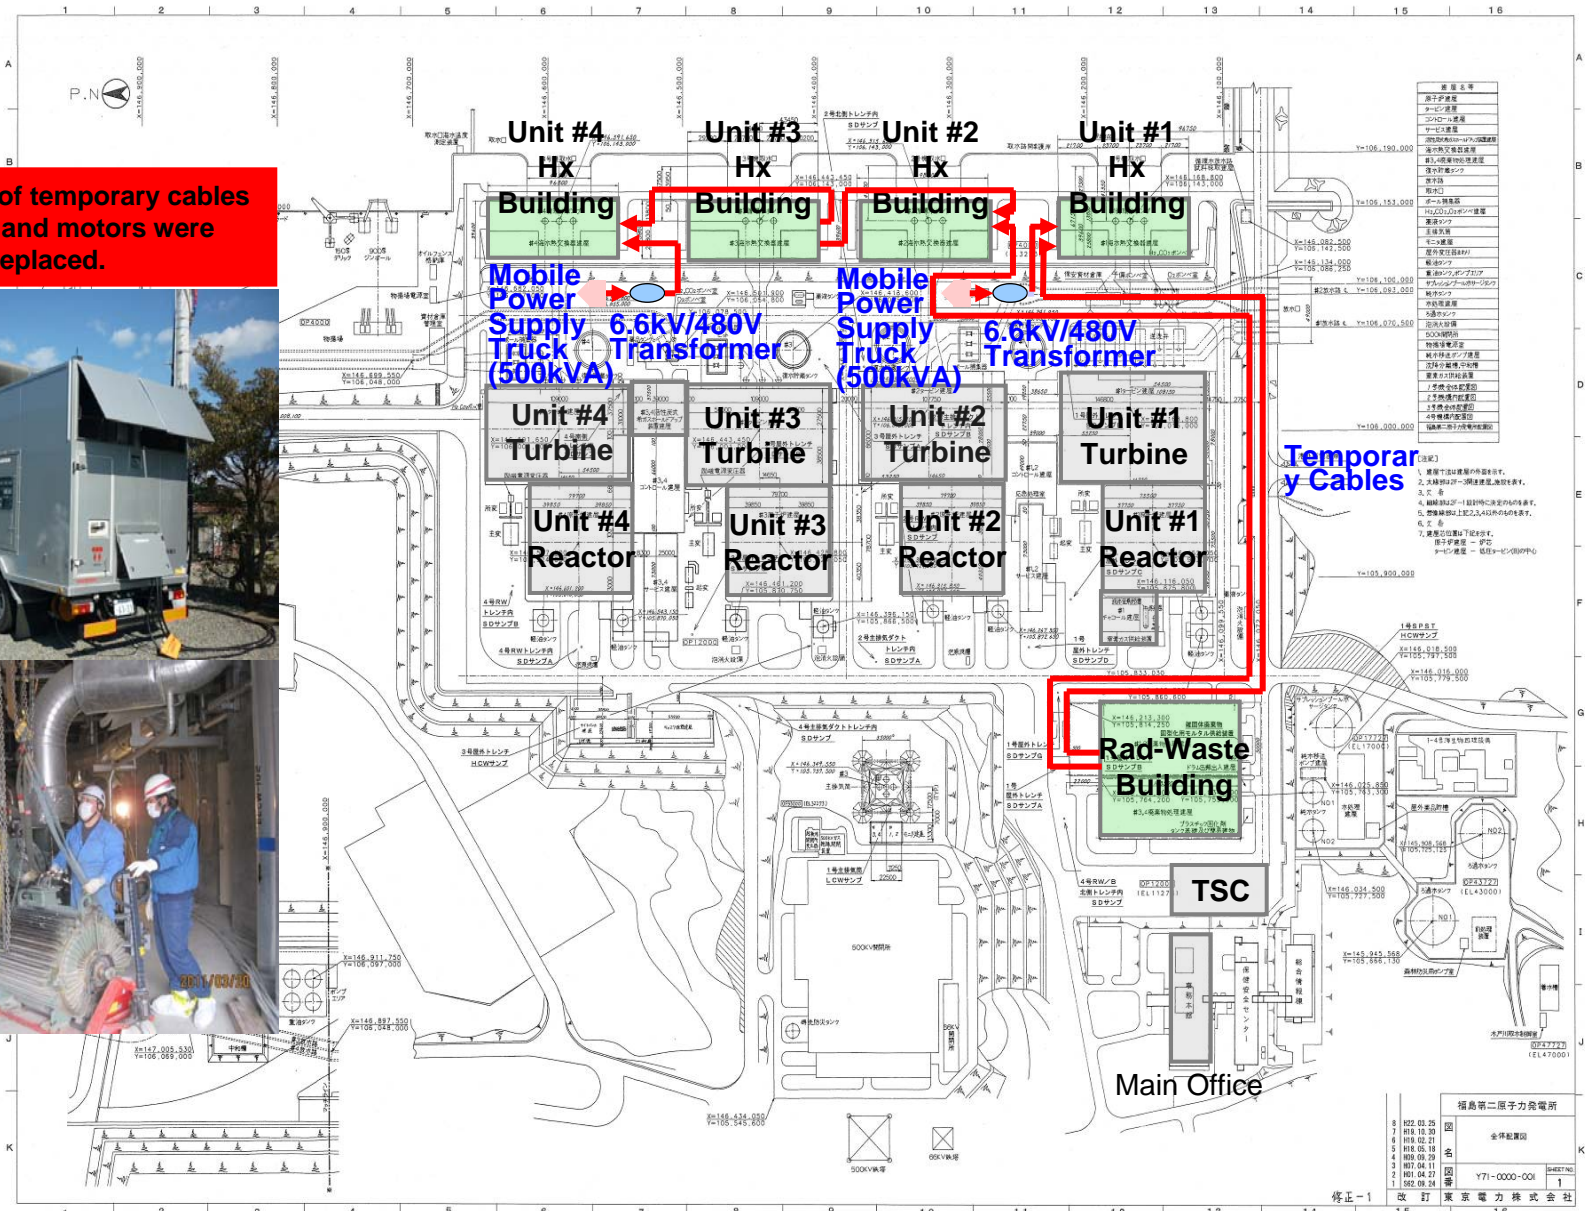
Temporary Power Supply and Motor Replacement @2F

About 9 km of temporary cables were laid and motors were replaced.
