Lessons learned from our accident at Fukushima Nuclear Power Stations

December 12, 2011

GLOBAL 2011 @Makuhari, Japan

Tokyo Electric Power Company

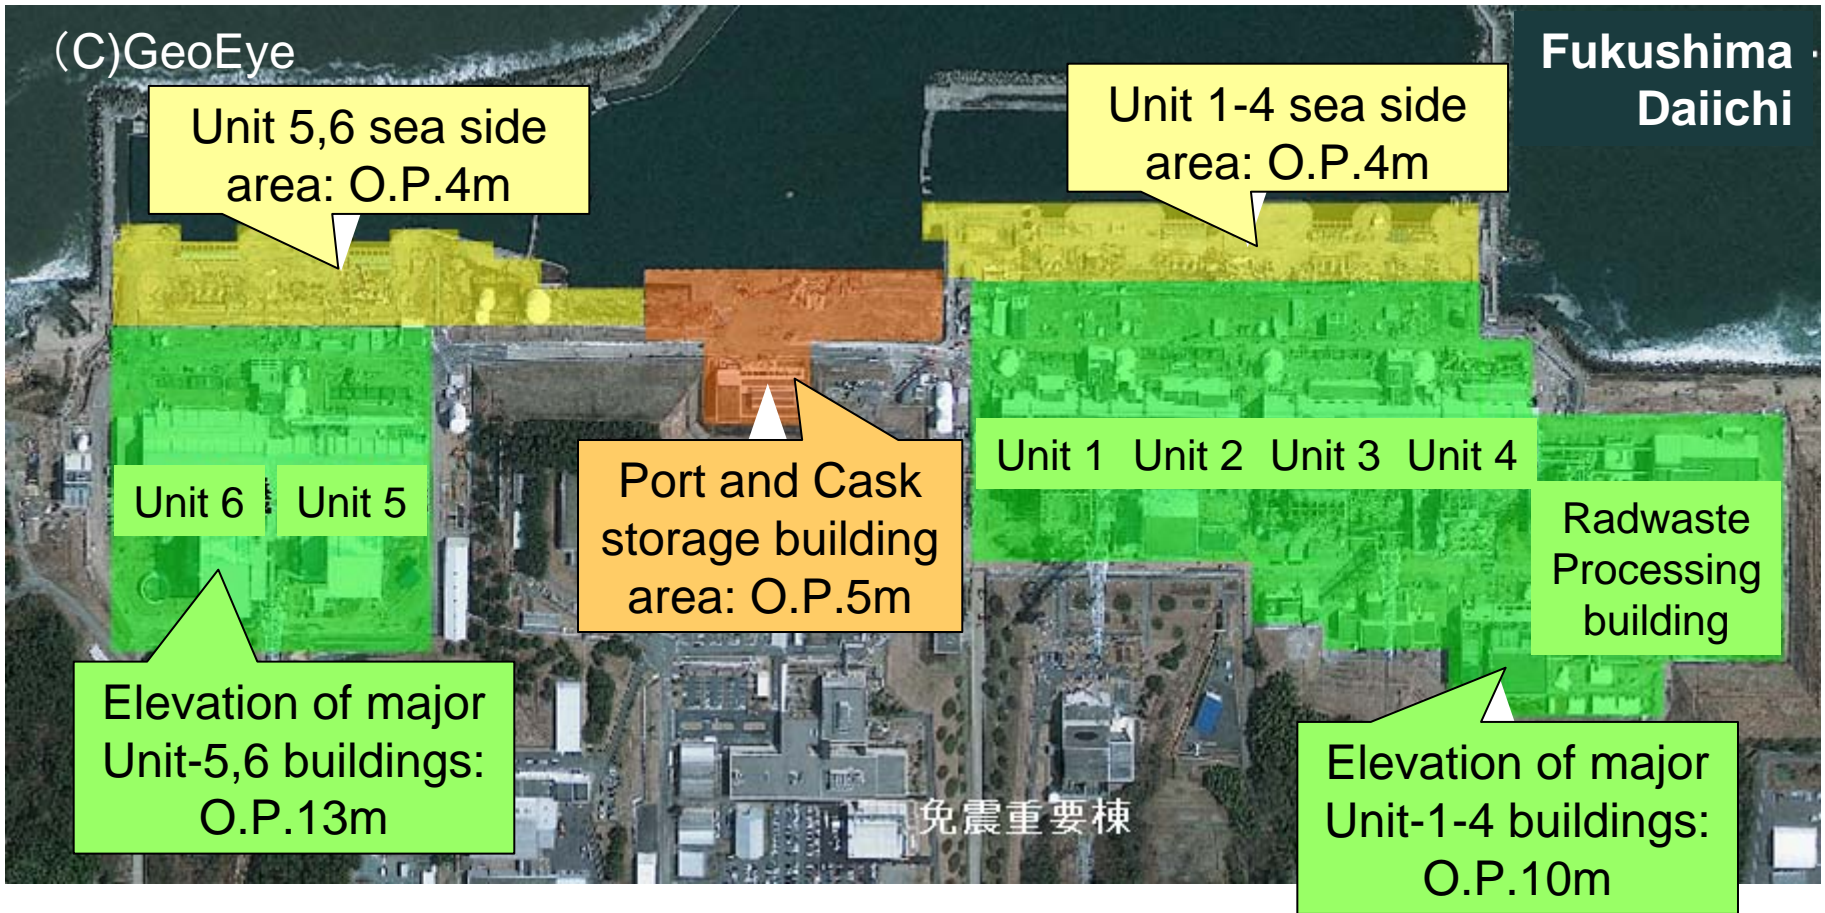
Elevation of the Fukushima Daiichi NPS

O.P.: Onahama Pile

Design-basis Tsunami height	Elevation of major buildings
5.7m	Unit 1-4: 10m
	Unit 5,6: 13m

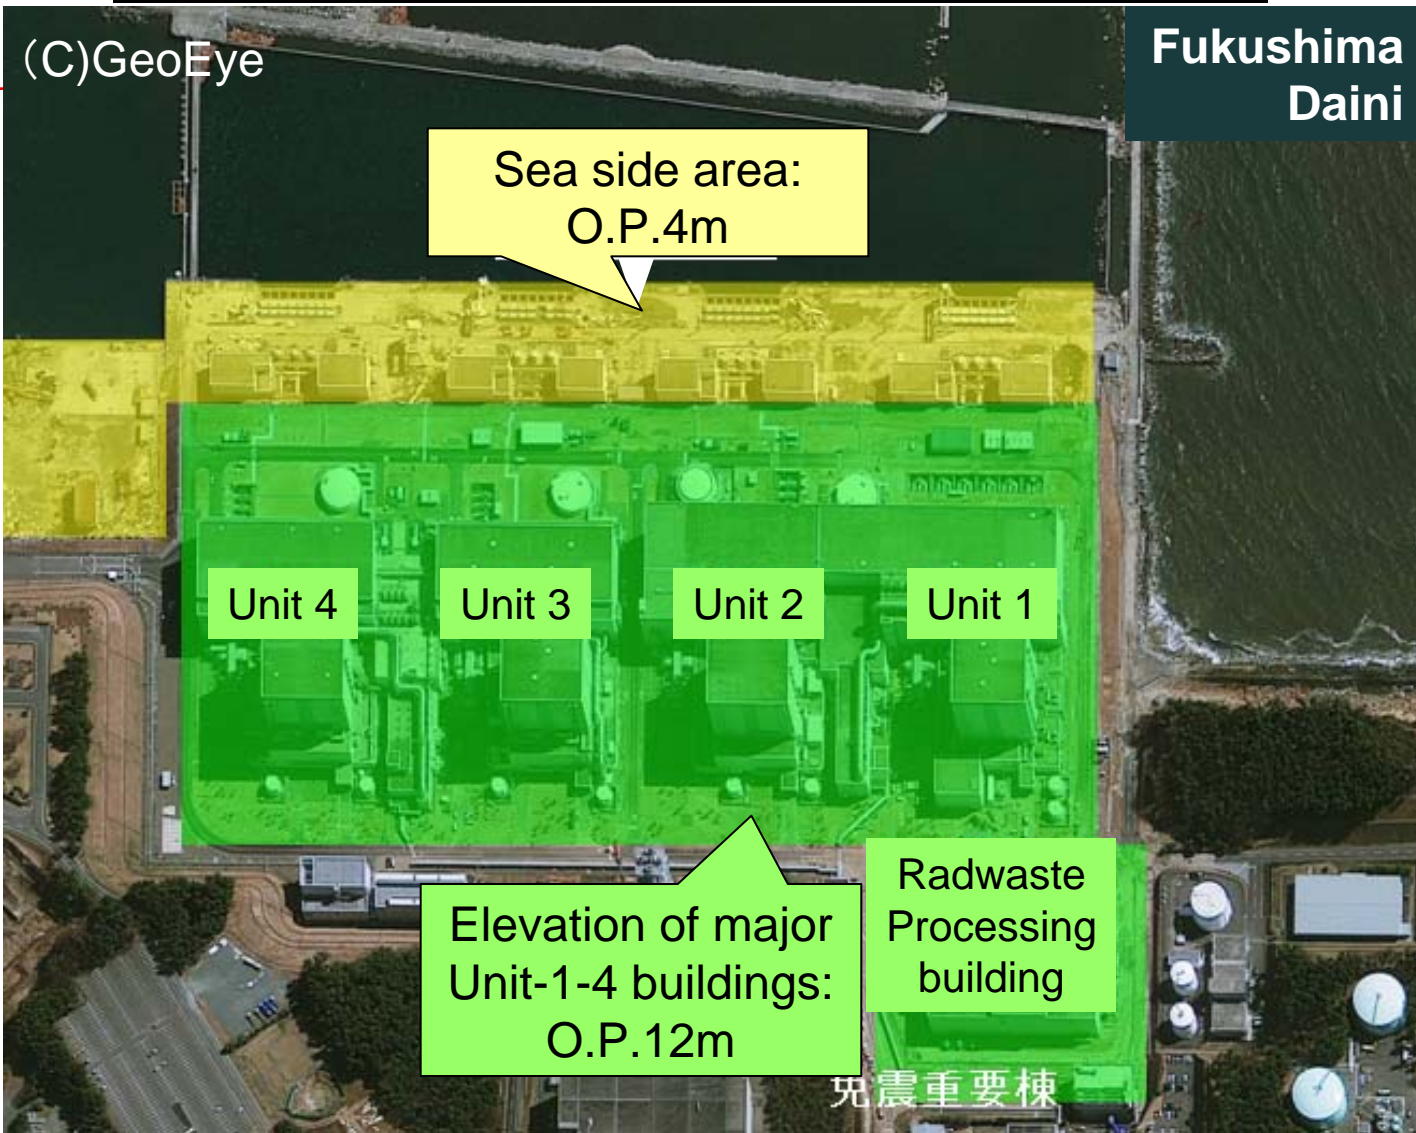
Elevation of the Fukushima Daini NPS

Design-basis Tsunami height	Elevation of major buildings
5.2m	12m

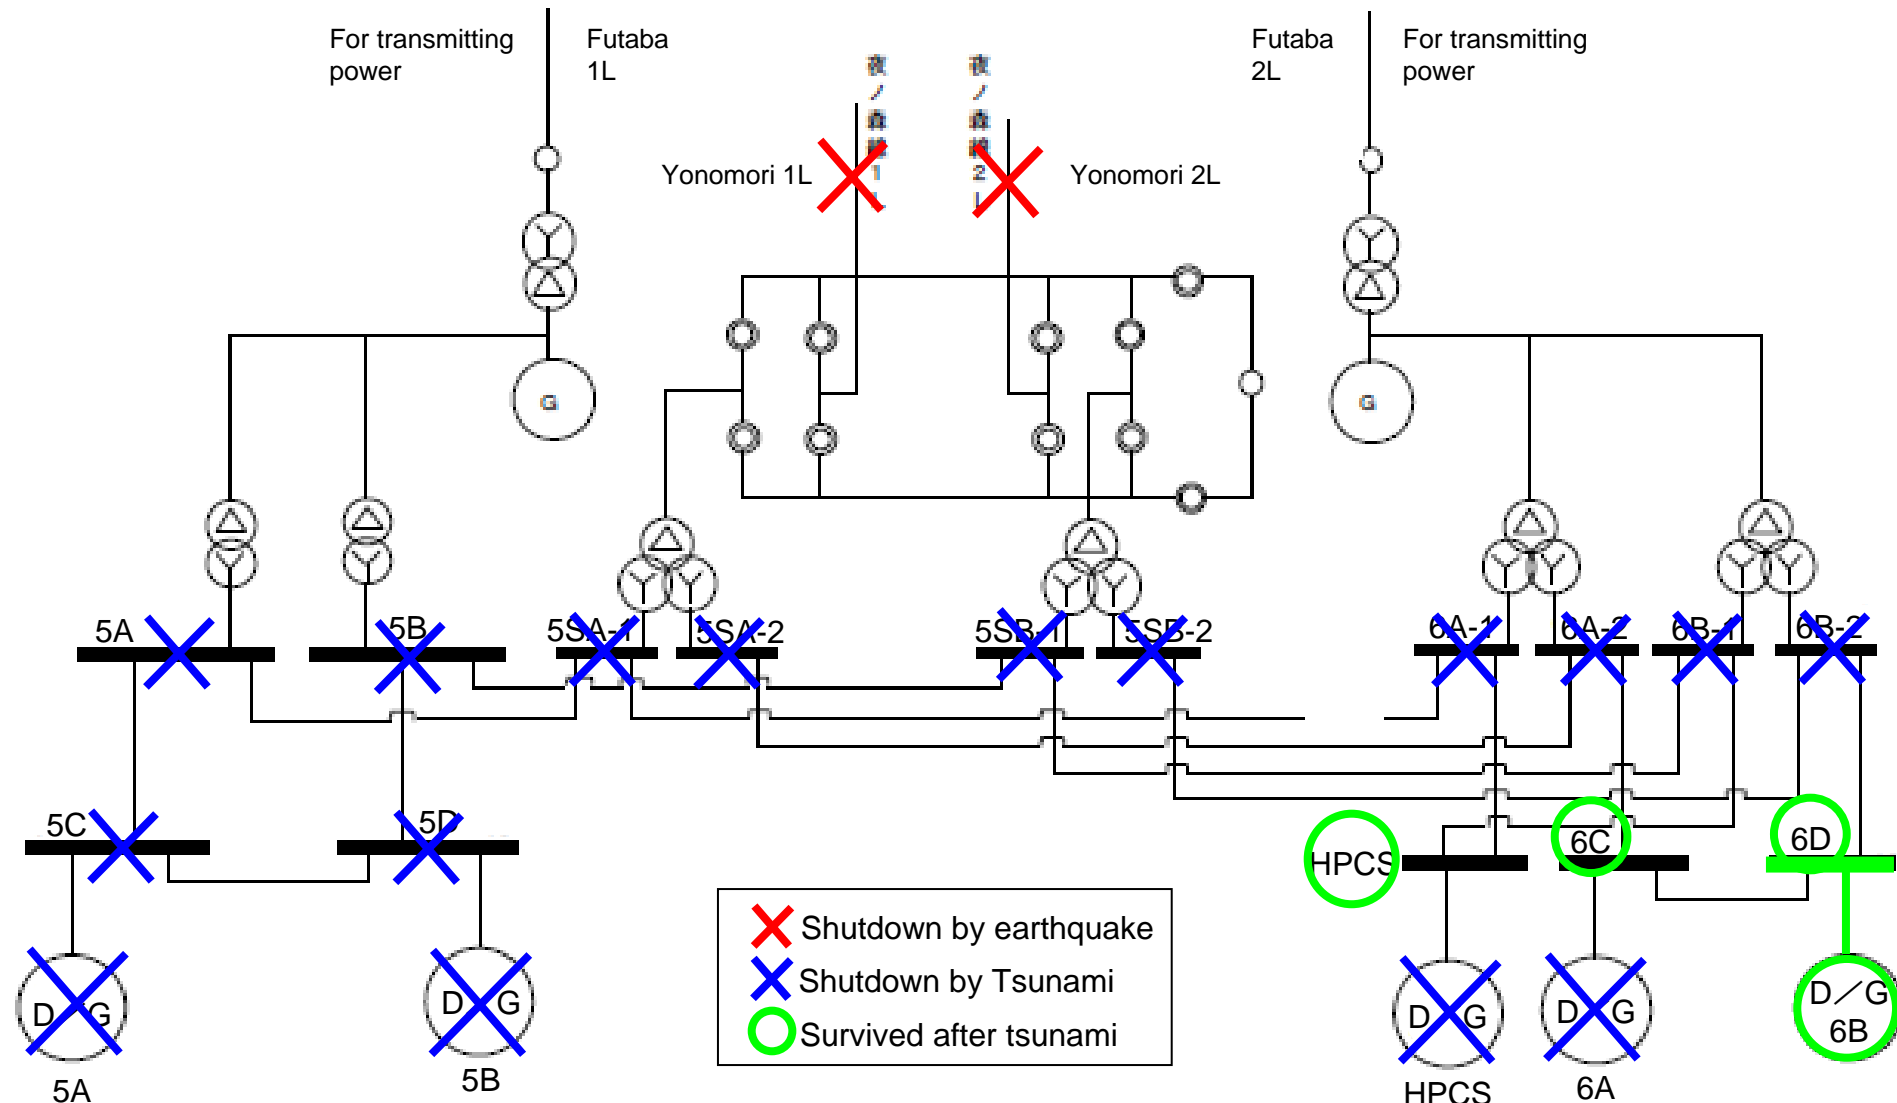
Power supply of Unit 5/6 @ 1F after Tsunami

The DG lost the function due to either "M/C failure," "loss of sea water system," or "DG main unit failure."

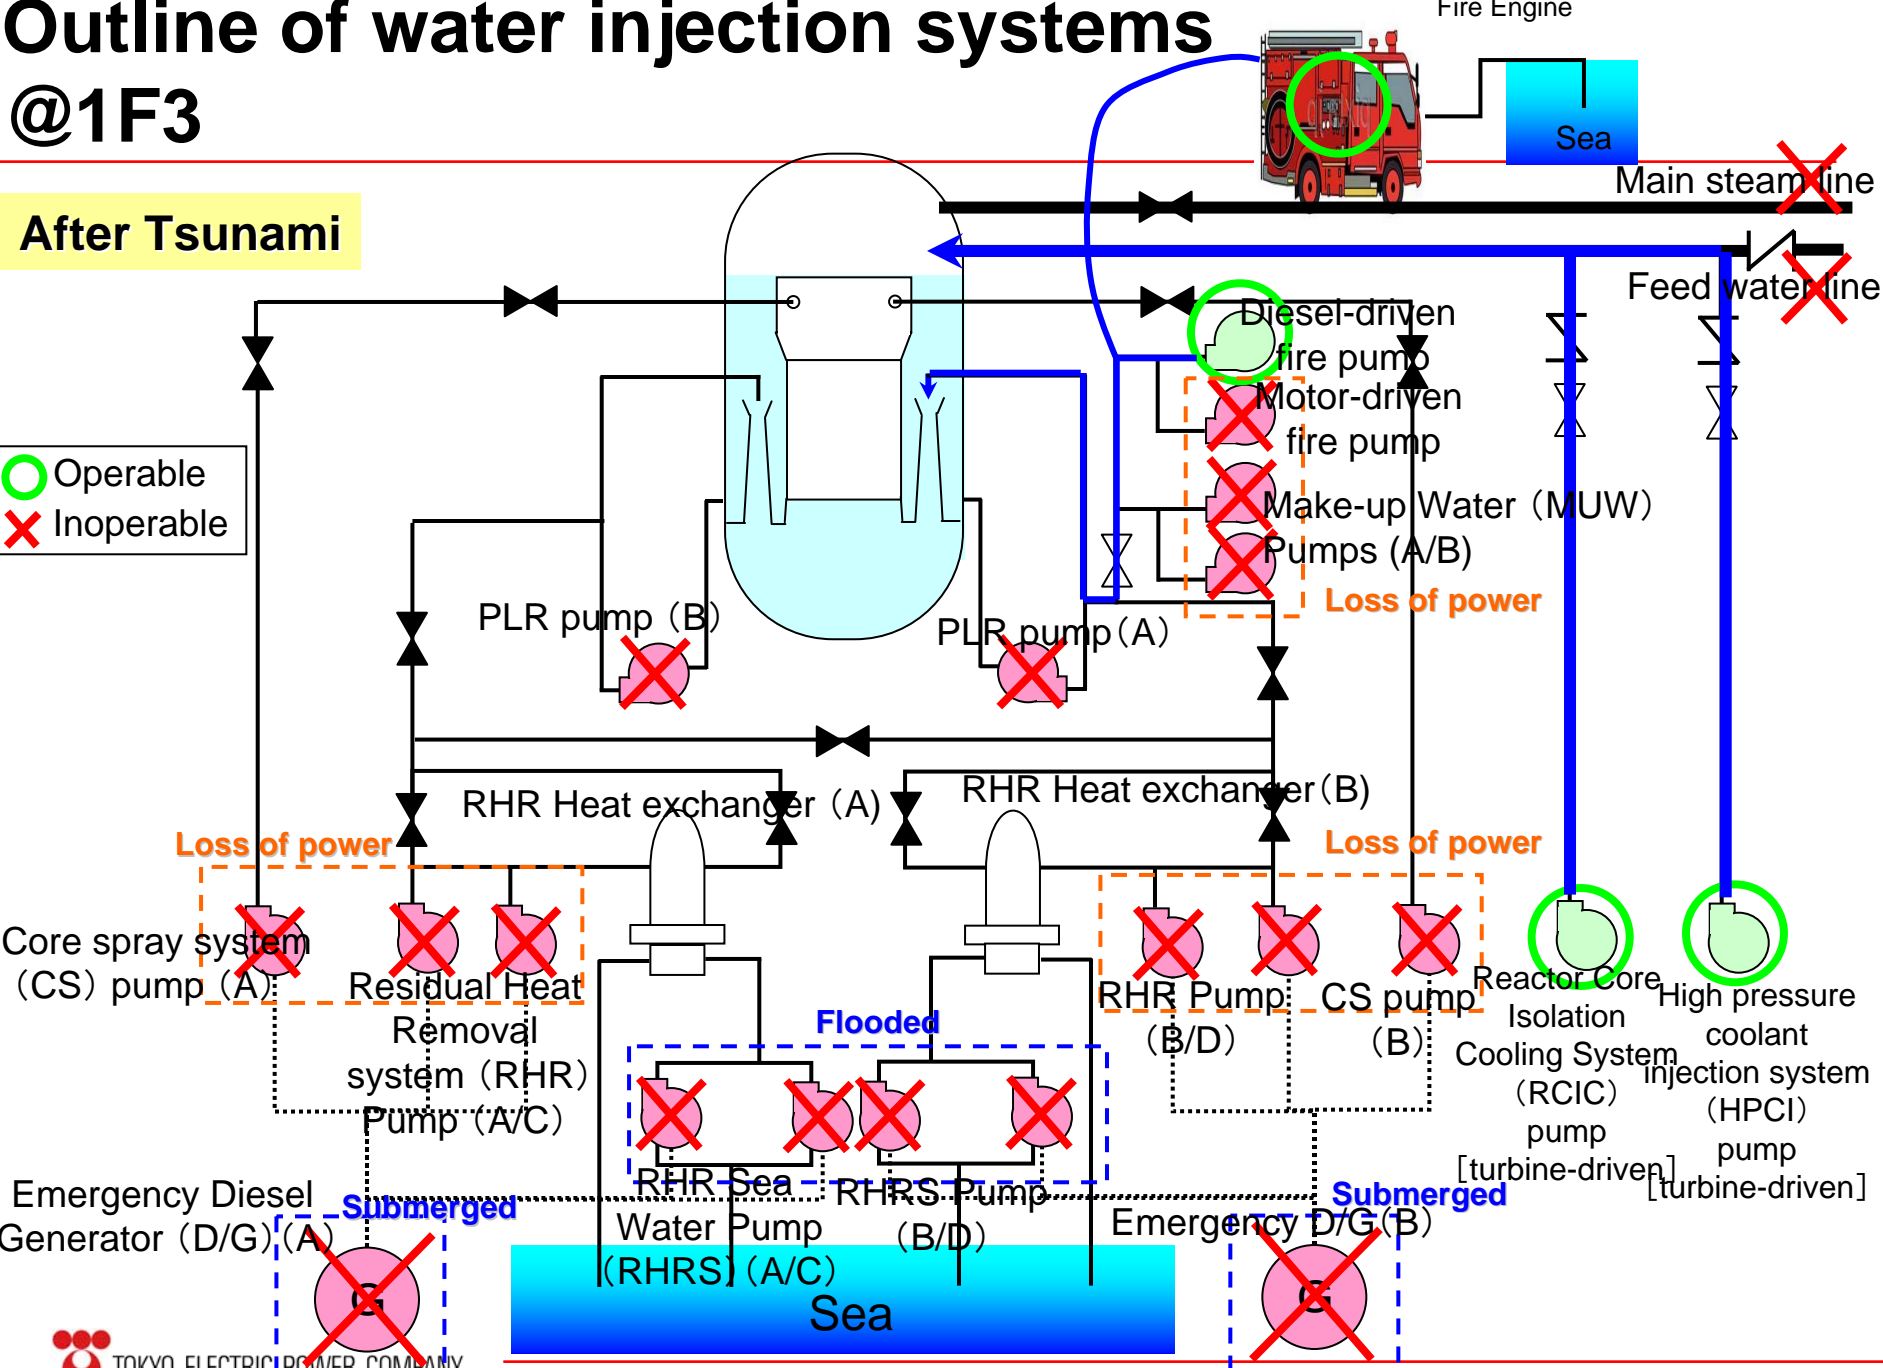
Outline of water injection systems

@1F3

After Tsunami

○ Operable
✗ Inoperable

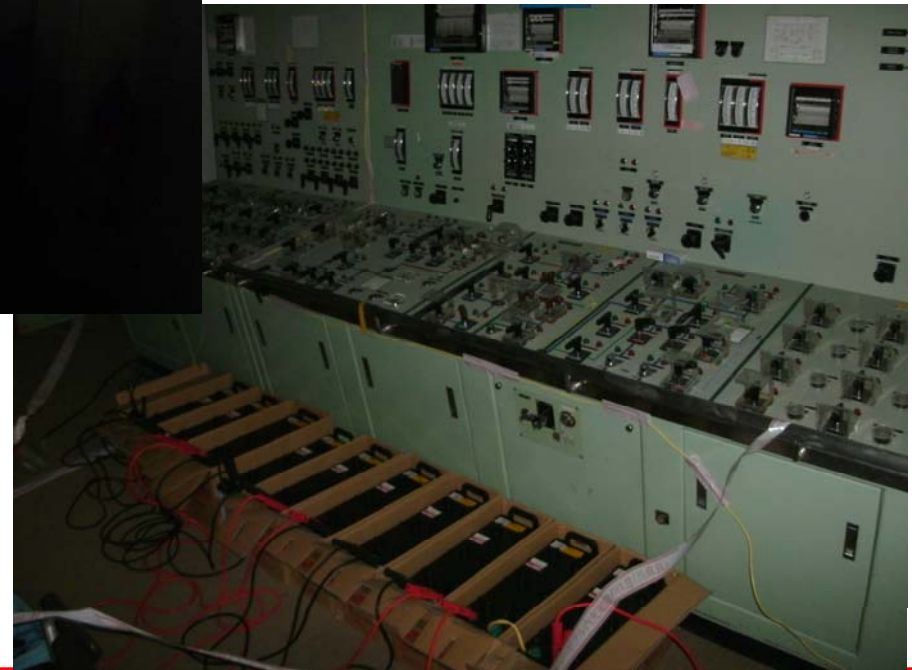
Instruments were monitored wearing a full face mask with a flashlight in complete darkness

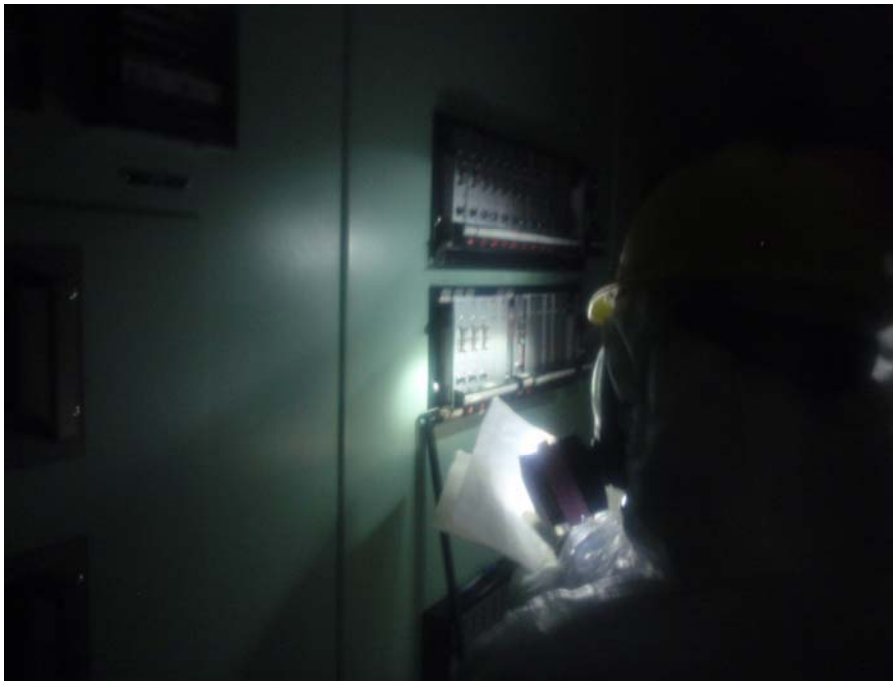
Supervising (1)

Check indicated values only with a flashlight in complete darkness

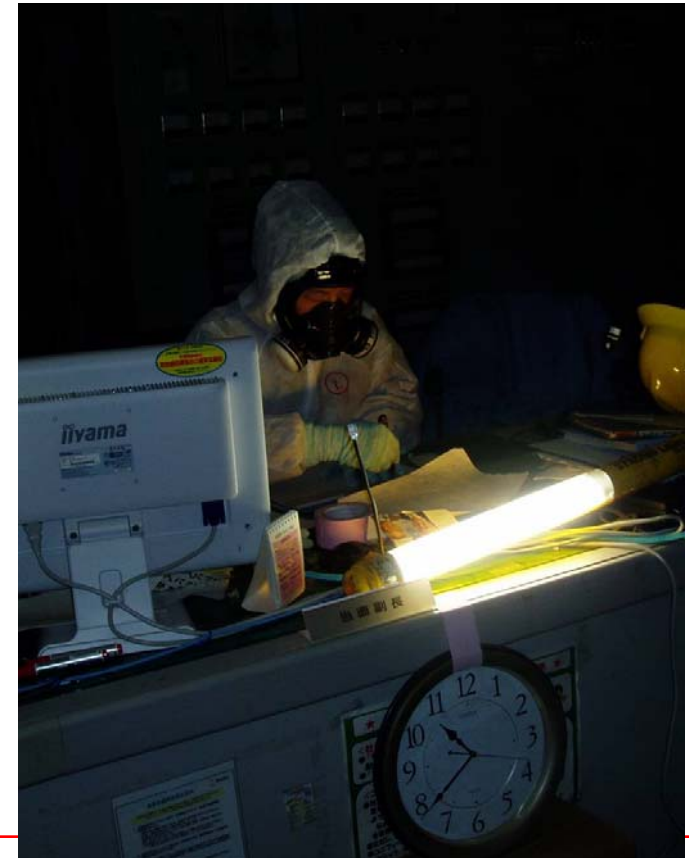
Supervising (2)

Supervising at a deputy supervisor's desk wearing a full face mask in complete darkness

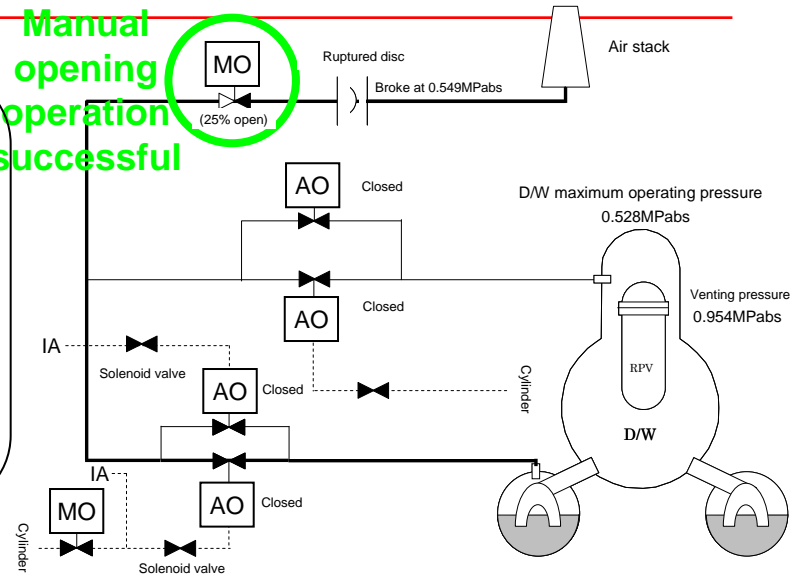
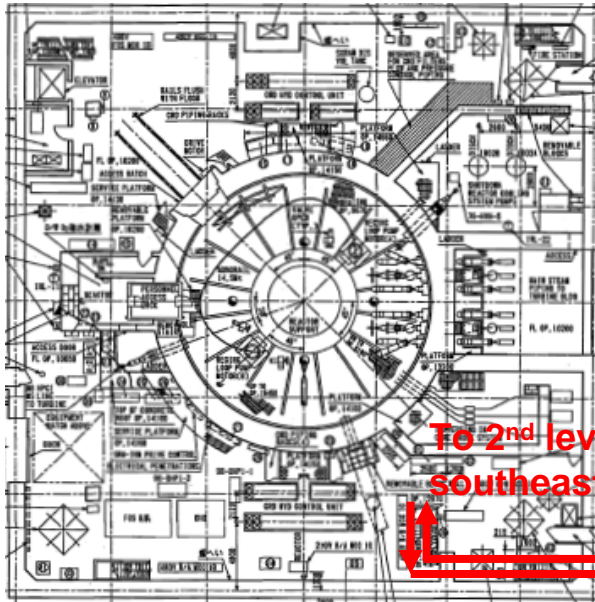
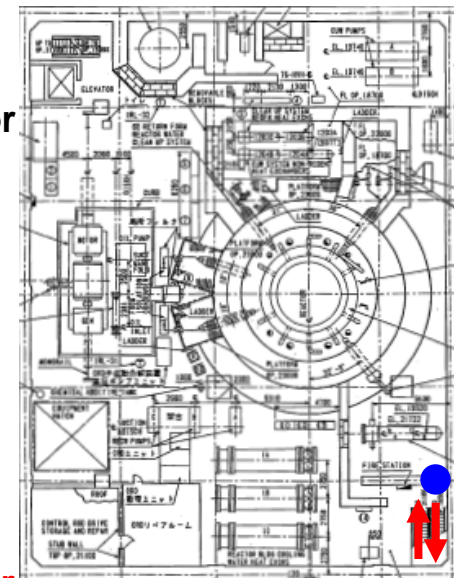
Access route to PCV vent valve (MO valve)

1st team proceeded to site to operate PCV vent valve (MO valve) on the 2nd level of the R/B, and implemented operation to open the valve manually.

Operation to open PCV vent valve (MO valve) successful

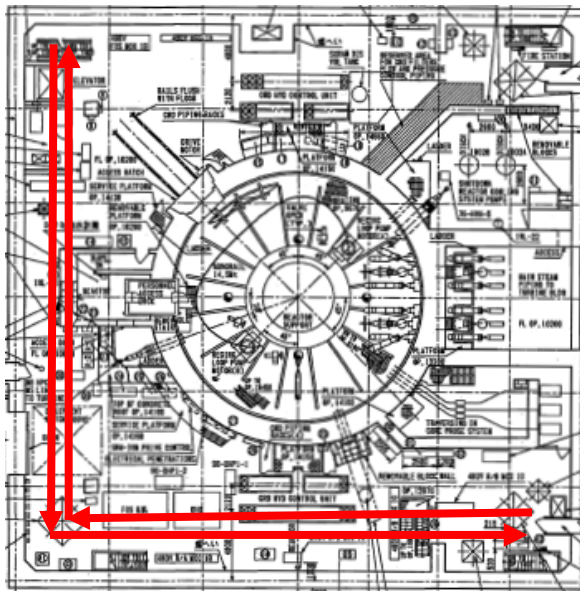
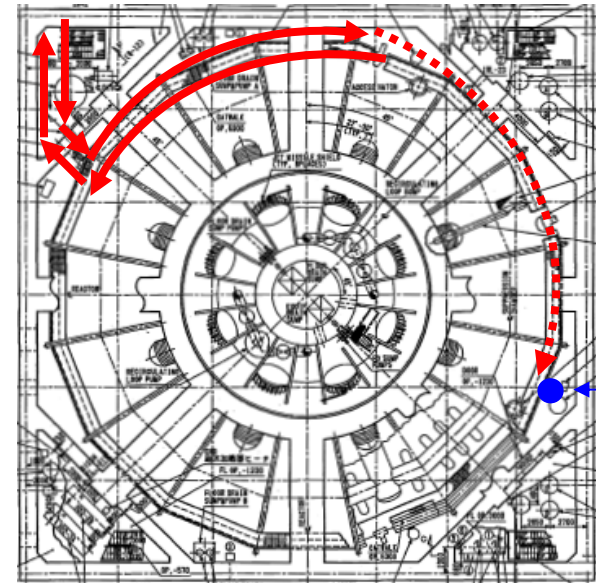
R/B B1F

- 2nd team entered the torus room (R/B B1F), but the valve was located at a direction of 180 degrees from where the team entered the torus room.
- The survey meter rose up to the limit on the way, and the team members returned.
- ➡ **Manual operation was abandoned and another means was selected**

Dose at the north-side double door was high, and south-bound course was selected

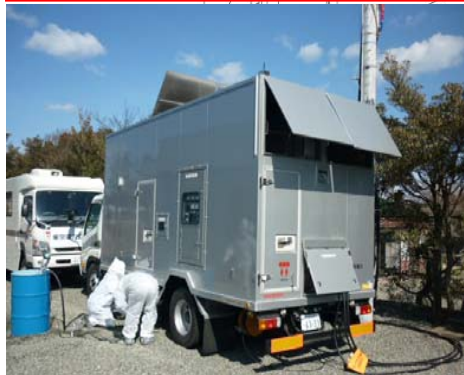
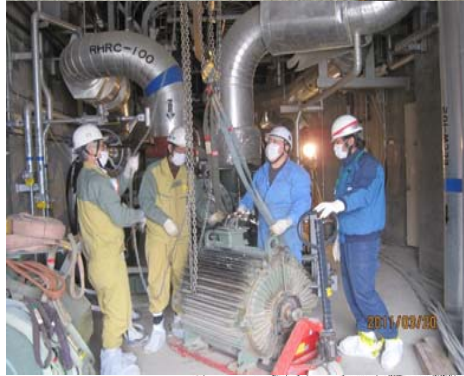
Temporary Power Supply and Motor Replacement @2F

About 9 km of temporary cables were laid and motors were replaced.

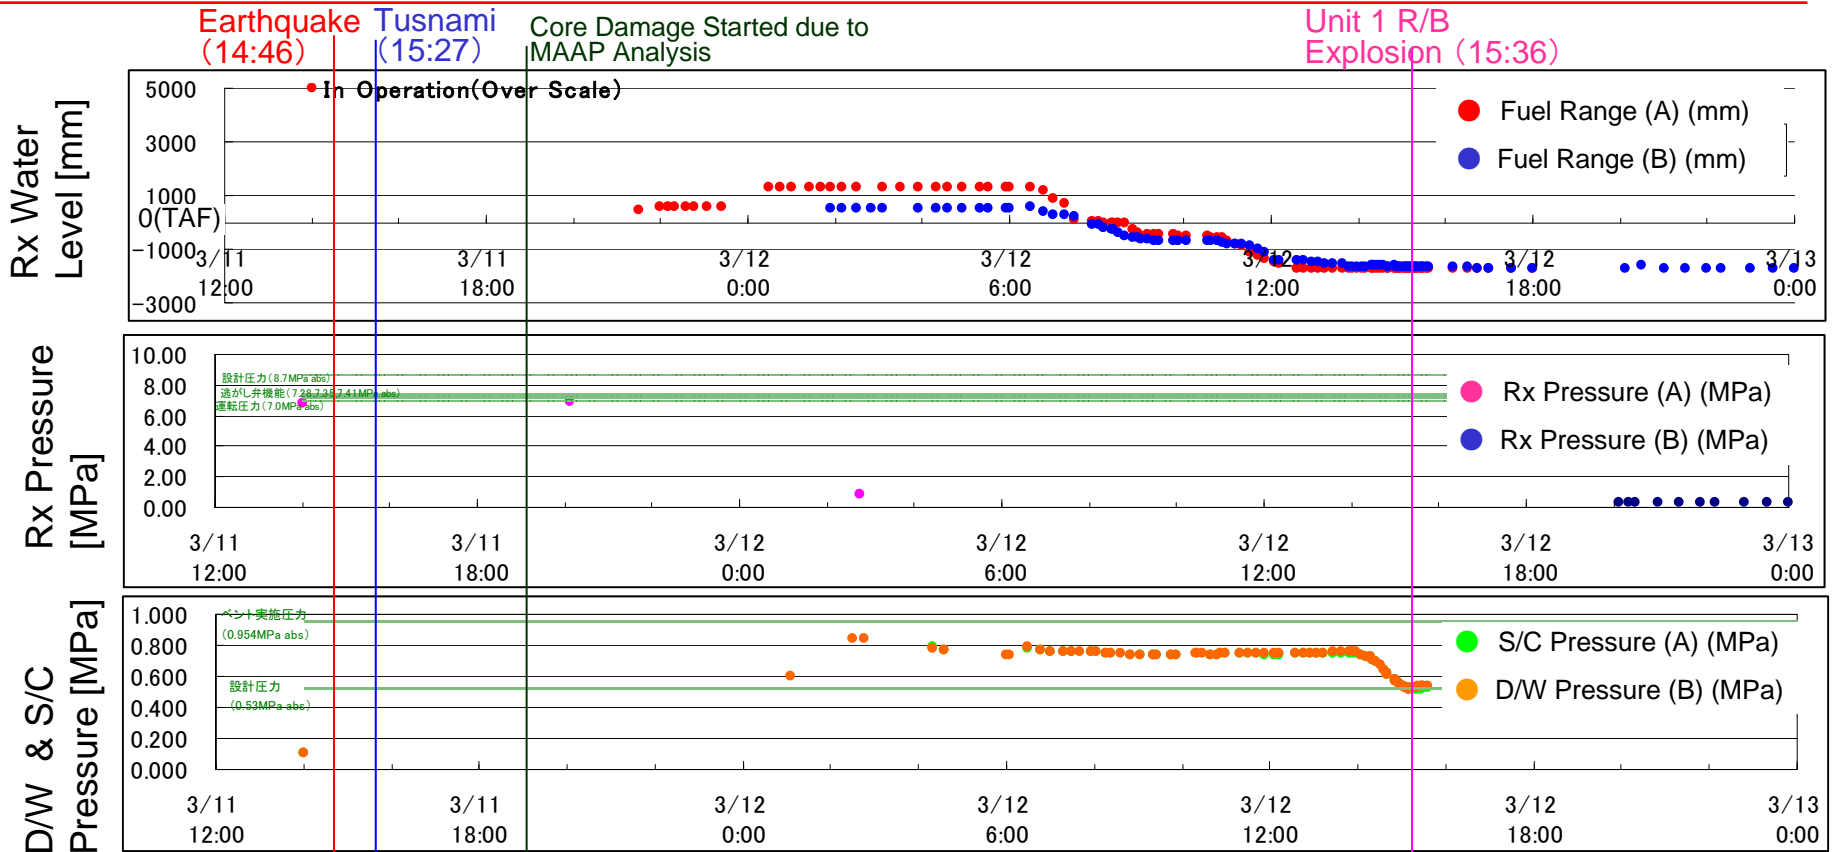
Fukushima Daiichi Unit 1 Plant Parameter and Operation

IC	(14:52) (18:18) (21:30) Operation Unclear
HPCI	No Operation
SRV	No Operation
FP/Fire Engine	(5:46) Fresh Water [80t] (14:53) (19:04) Sea Water
PCV Vent	Order for Vent Preparation (0:06) Order for Vent (8:03) (14:30) D/W Pr decrease confirmed

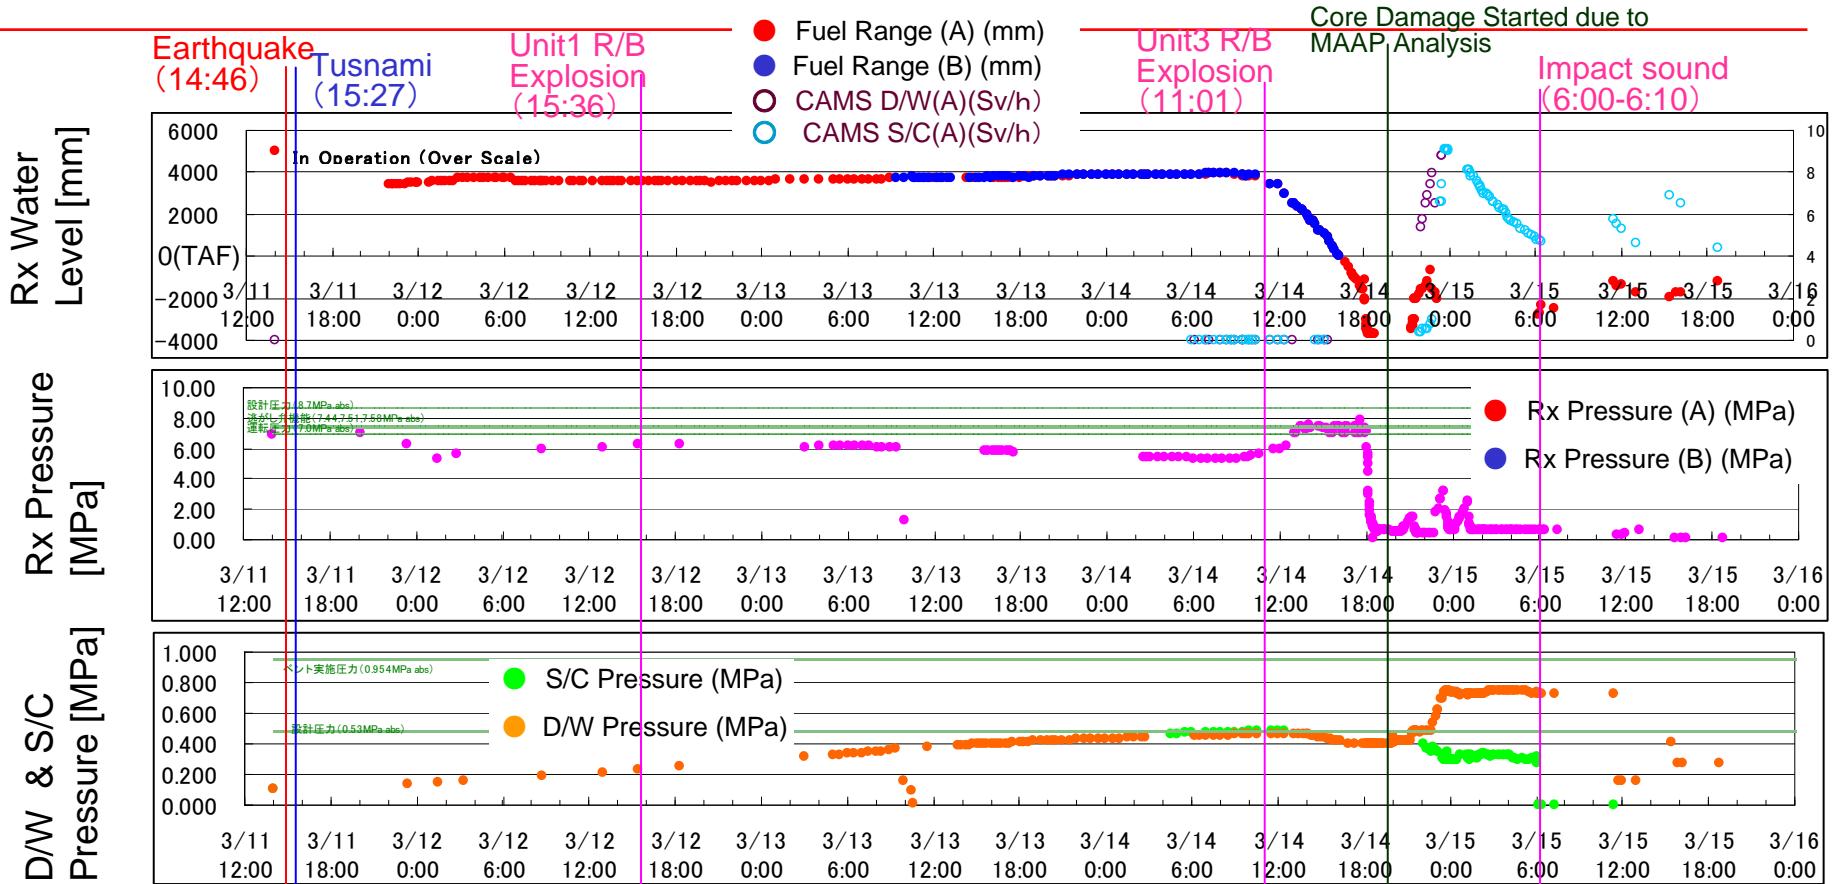
Fukushima Daiichi Unit 2 Plant Parameter and Operation

RCIC		▼(2:55) Operation confirmed	(13:25) Out of Service Judged
HPCI	No Operation		Depressurization (19:54) Valve Condition Unclear
SRV			(~18:00) 2Valves Open
FP/Fire Engine		Order for Sea Water Injection Preparation (12:05) ▼	(19:54) Sea Water
PCV Vent	Order for Vent Preparation ▼ (17:30)	▼(11:00) Vent Line Configuration Completed	Small Vent Valves Opened

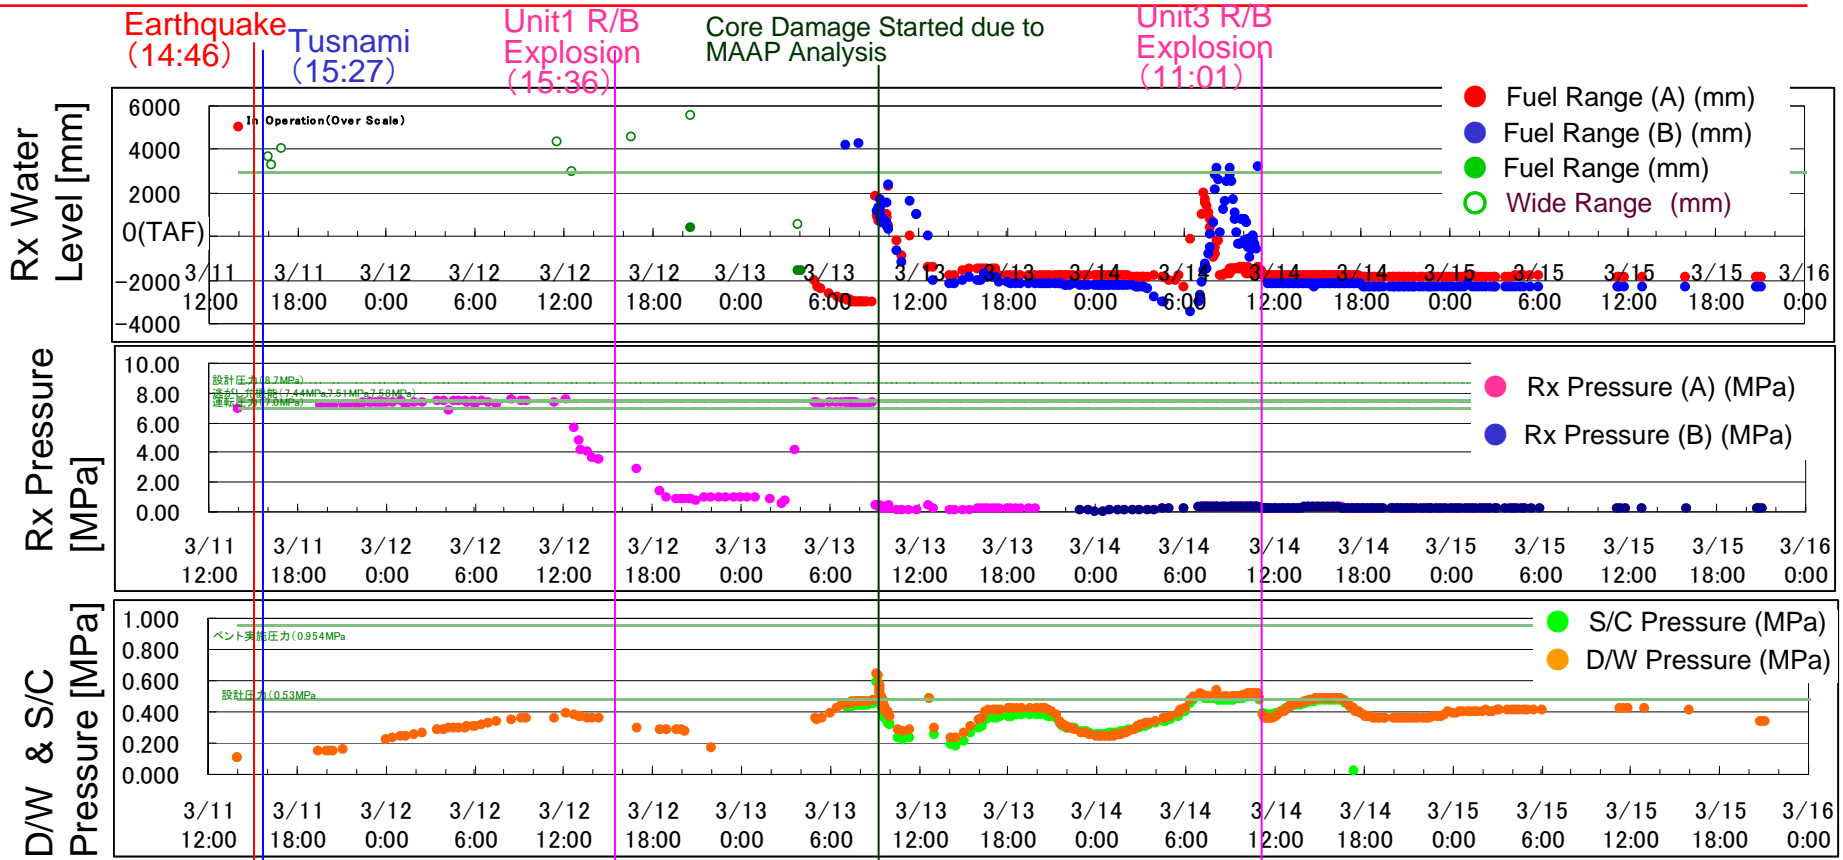
Fukushima Daiichi Unit 3 Plant Parameter and Operation

RCIC	(16:03) Trip (11:36) Trip
HPCI	Automatic Start (12:35) Trip (2:42)
SRV	(~9:08) Depressurization
FP/Fire Engine	Order for Preparation (17:12) Fresh Water (9:25) Sea Water (13:12) Sea Water (16:30)
PCV Vent	Order for Vent Preparation (17:30) (8:40) Vent Line Configuration Completed
